AGRICULTURAL IMPACTS

Resulting From Wind Farm Construction

October 2005

NYS Department of Agriculture & Markets

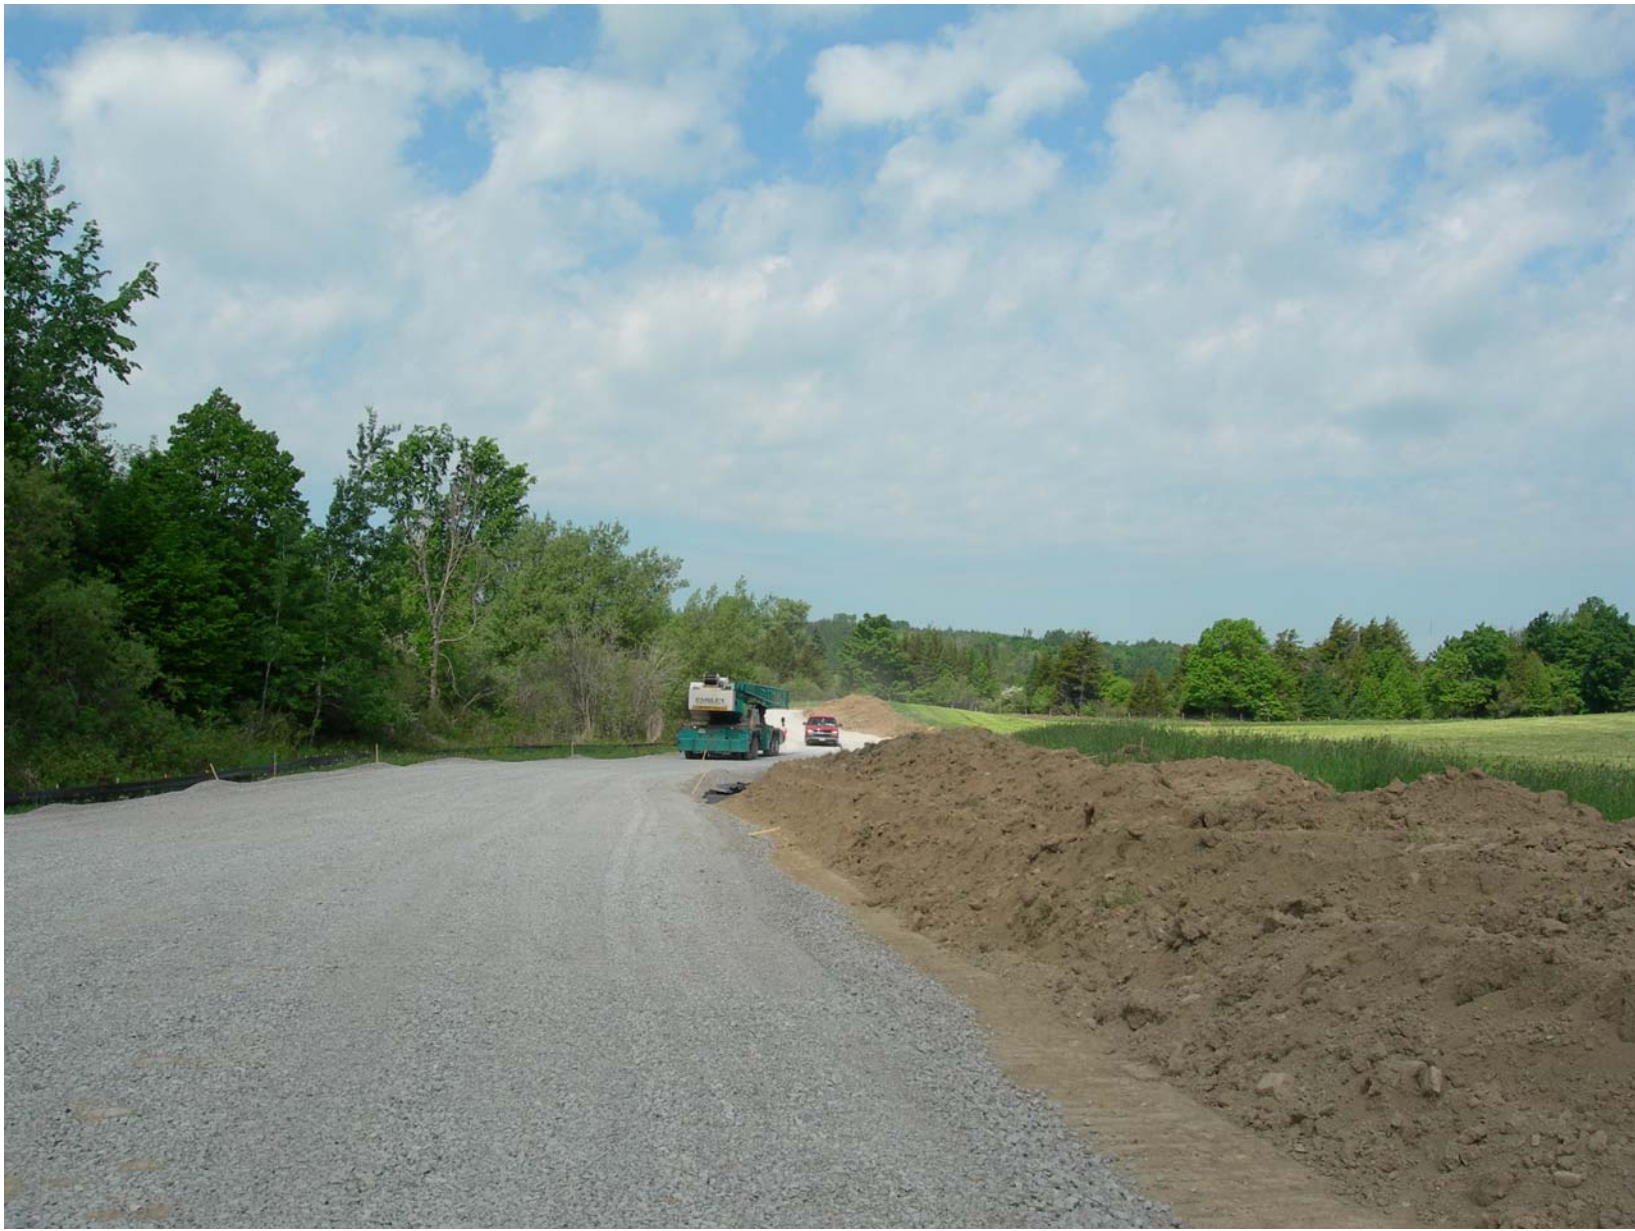
Access road located along field edge to minimize disturbance to field and cropping pattern.

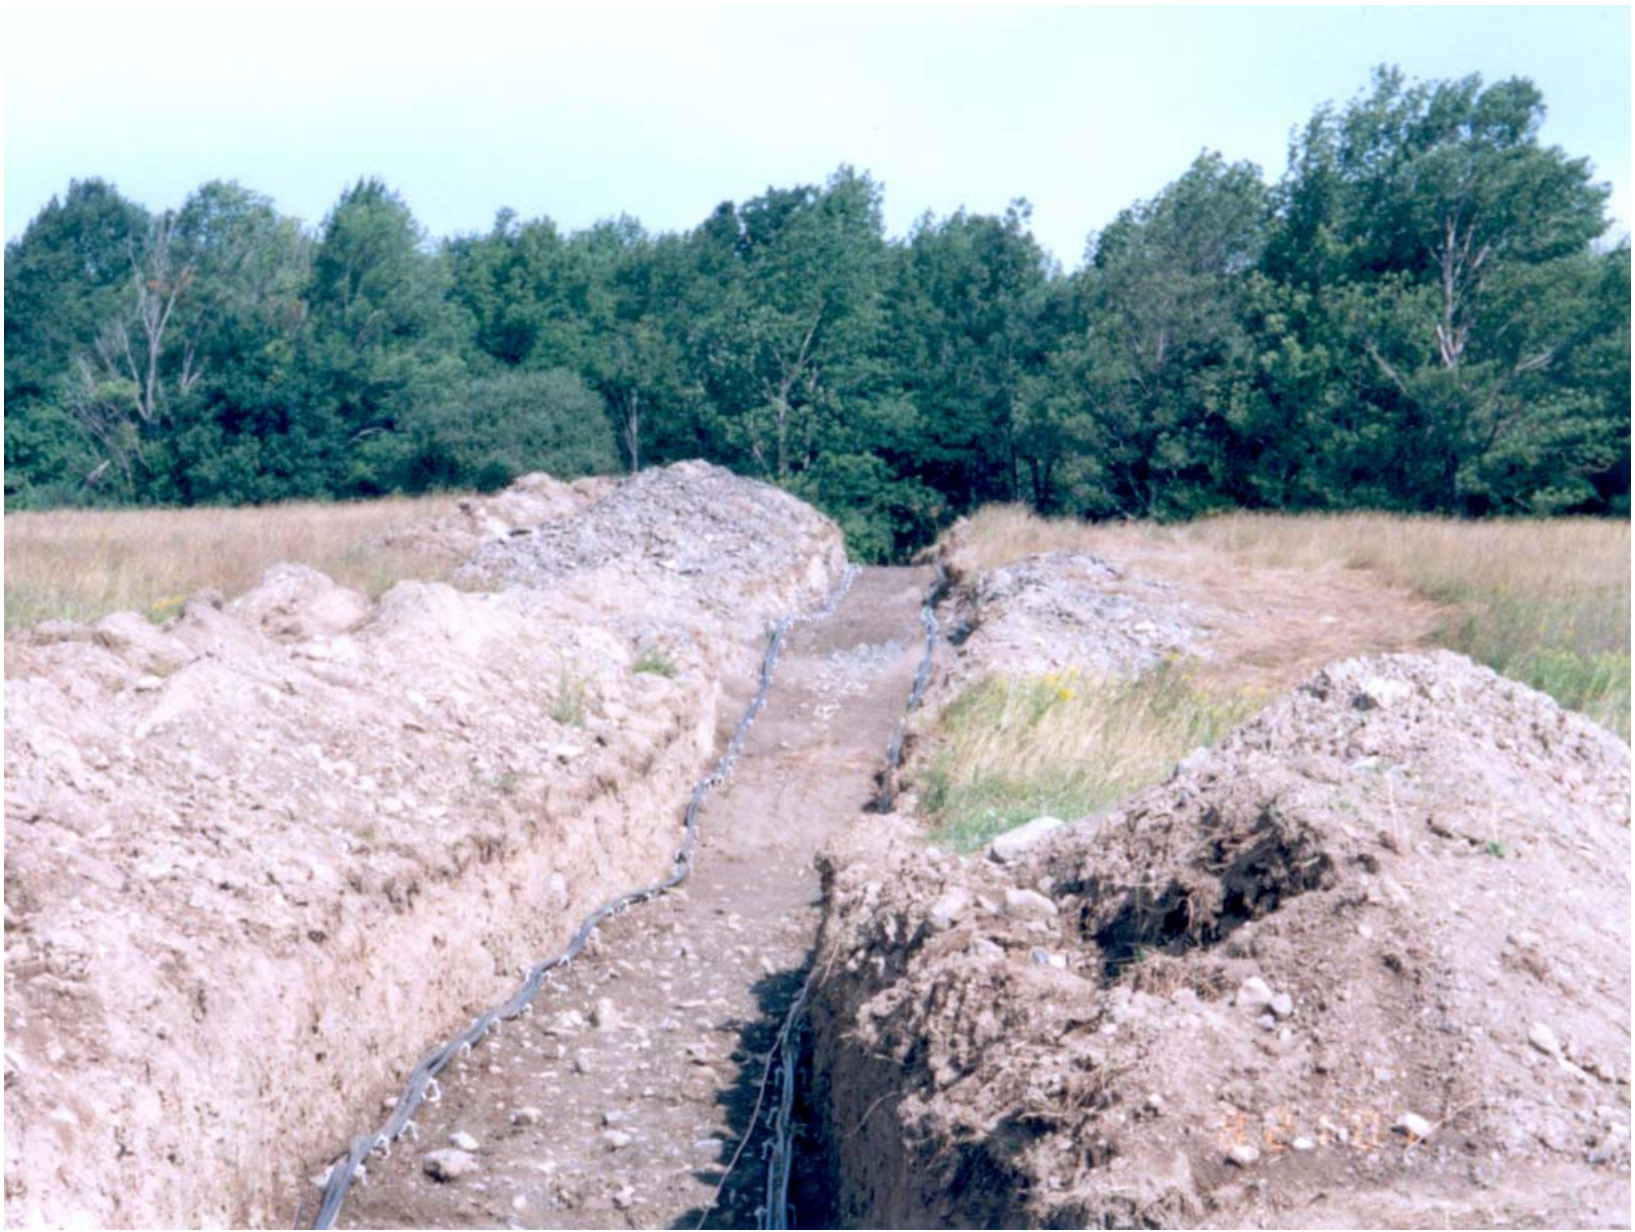
Trenches excavated for the collector system can cause significant impact to farm fields. This photo shows poor separation of topsoil and subsoil.

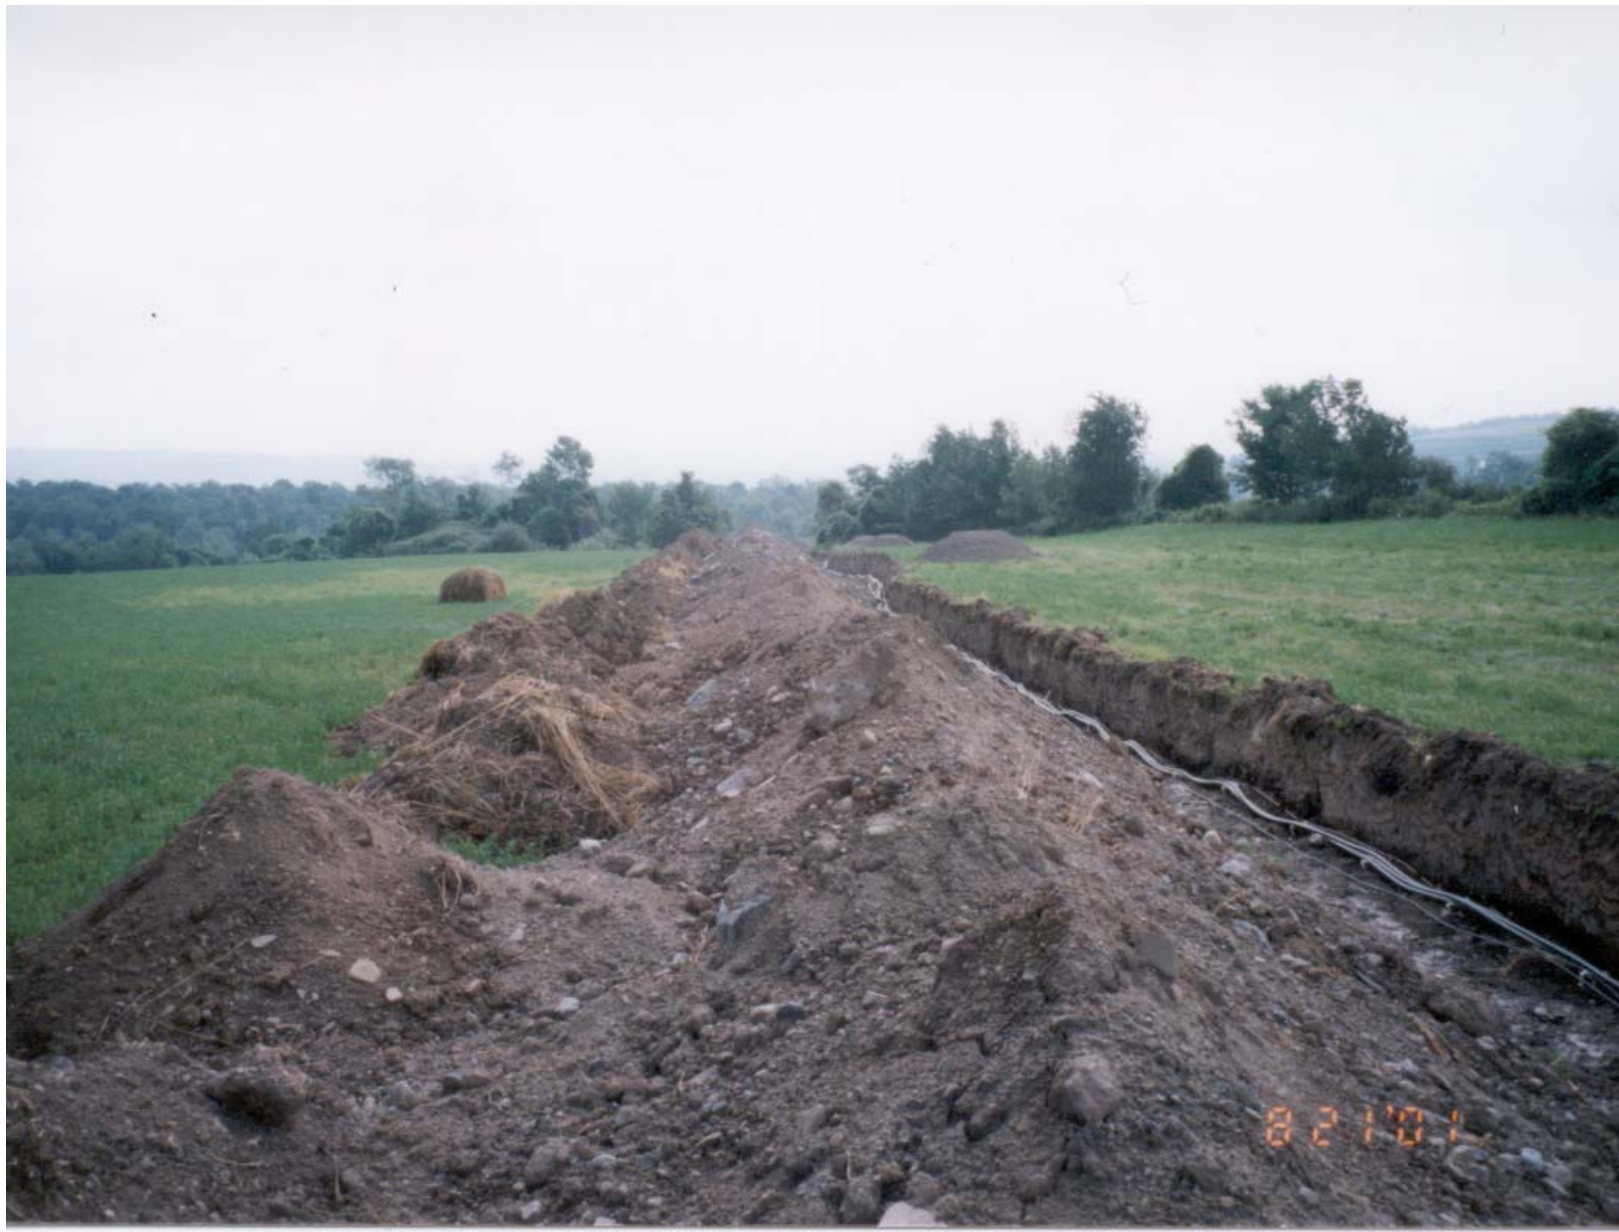
The contractor attempted to separate the topsoil (left side) from the subsoil material (right side). Some mixing did occur because of limited work space.

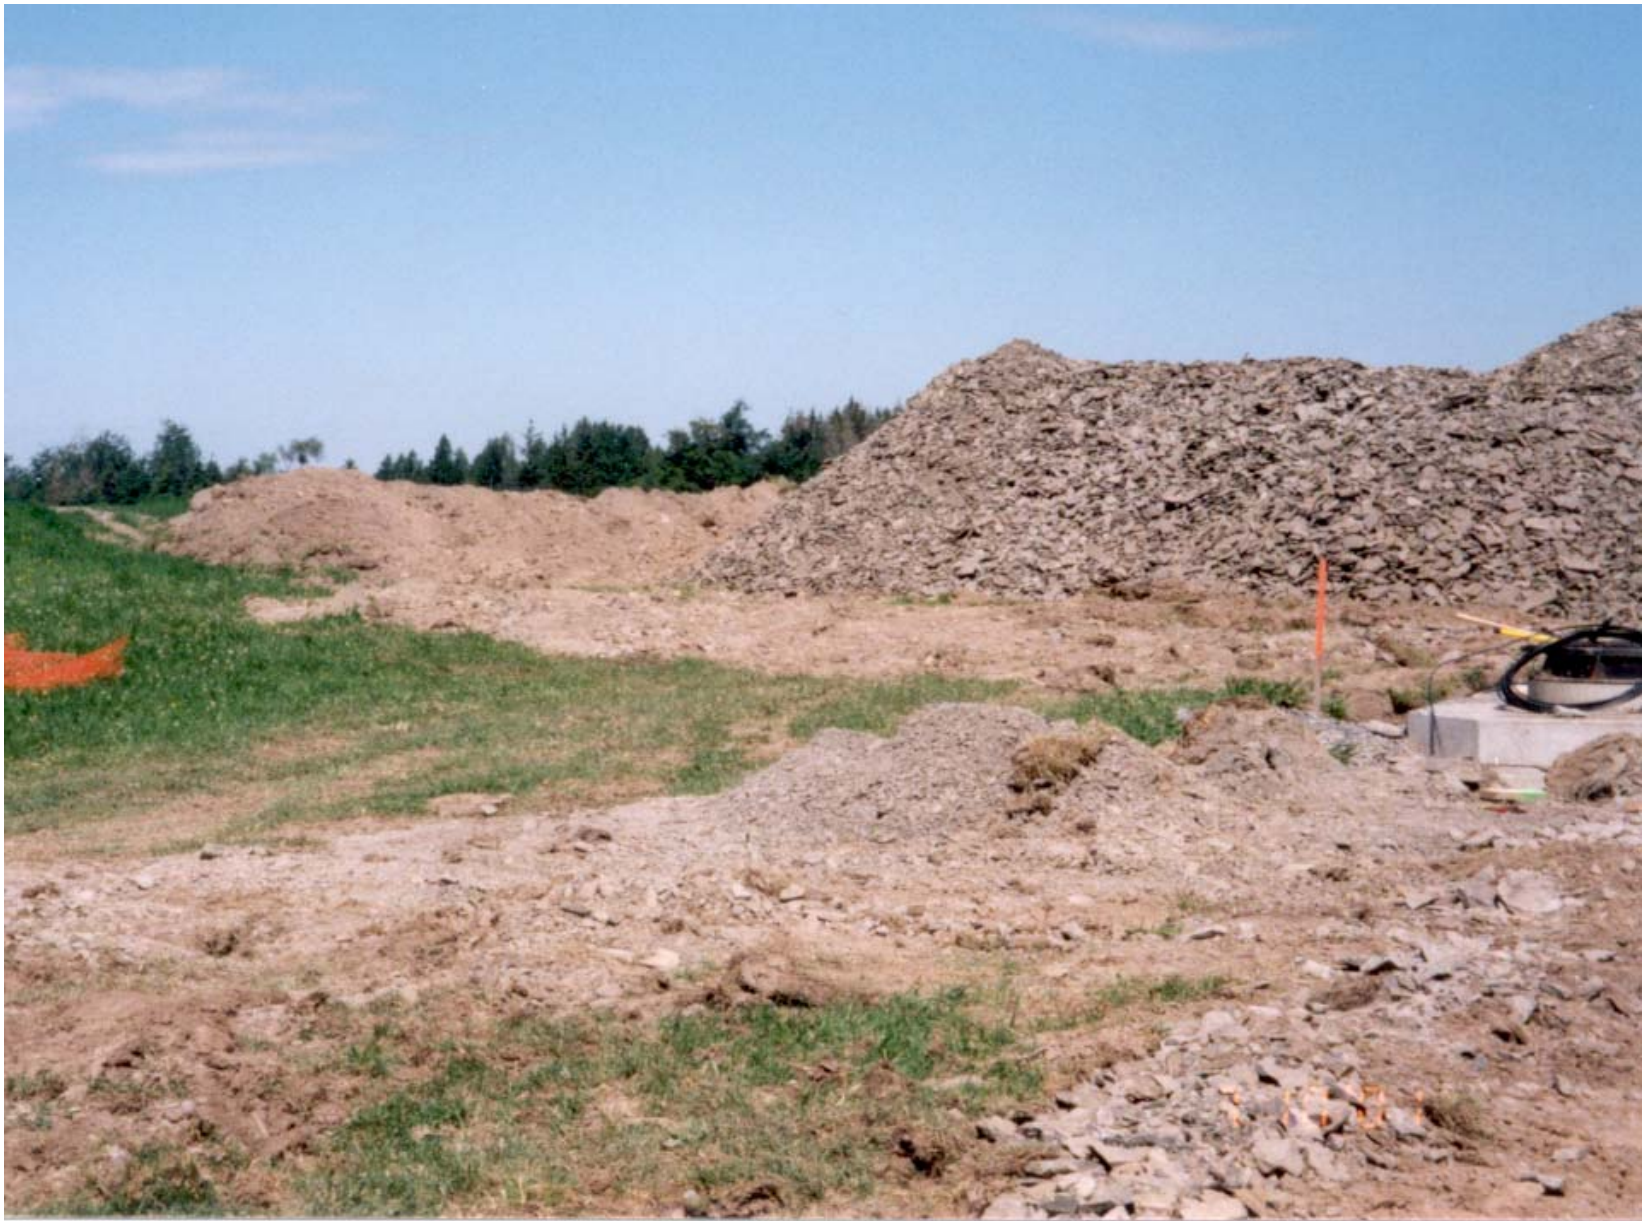
Significant volume of rock excavated from the hole for the foundation. Keeping this material separate from the topsoil is critical. The topsoil material is properly separated and temporarily stored on the left side.

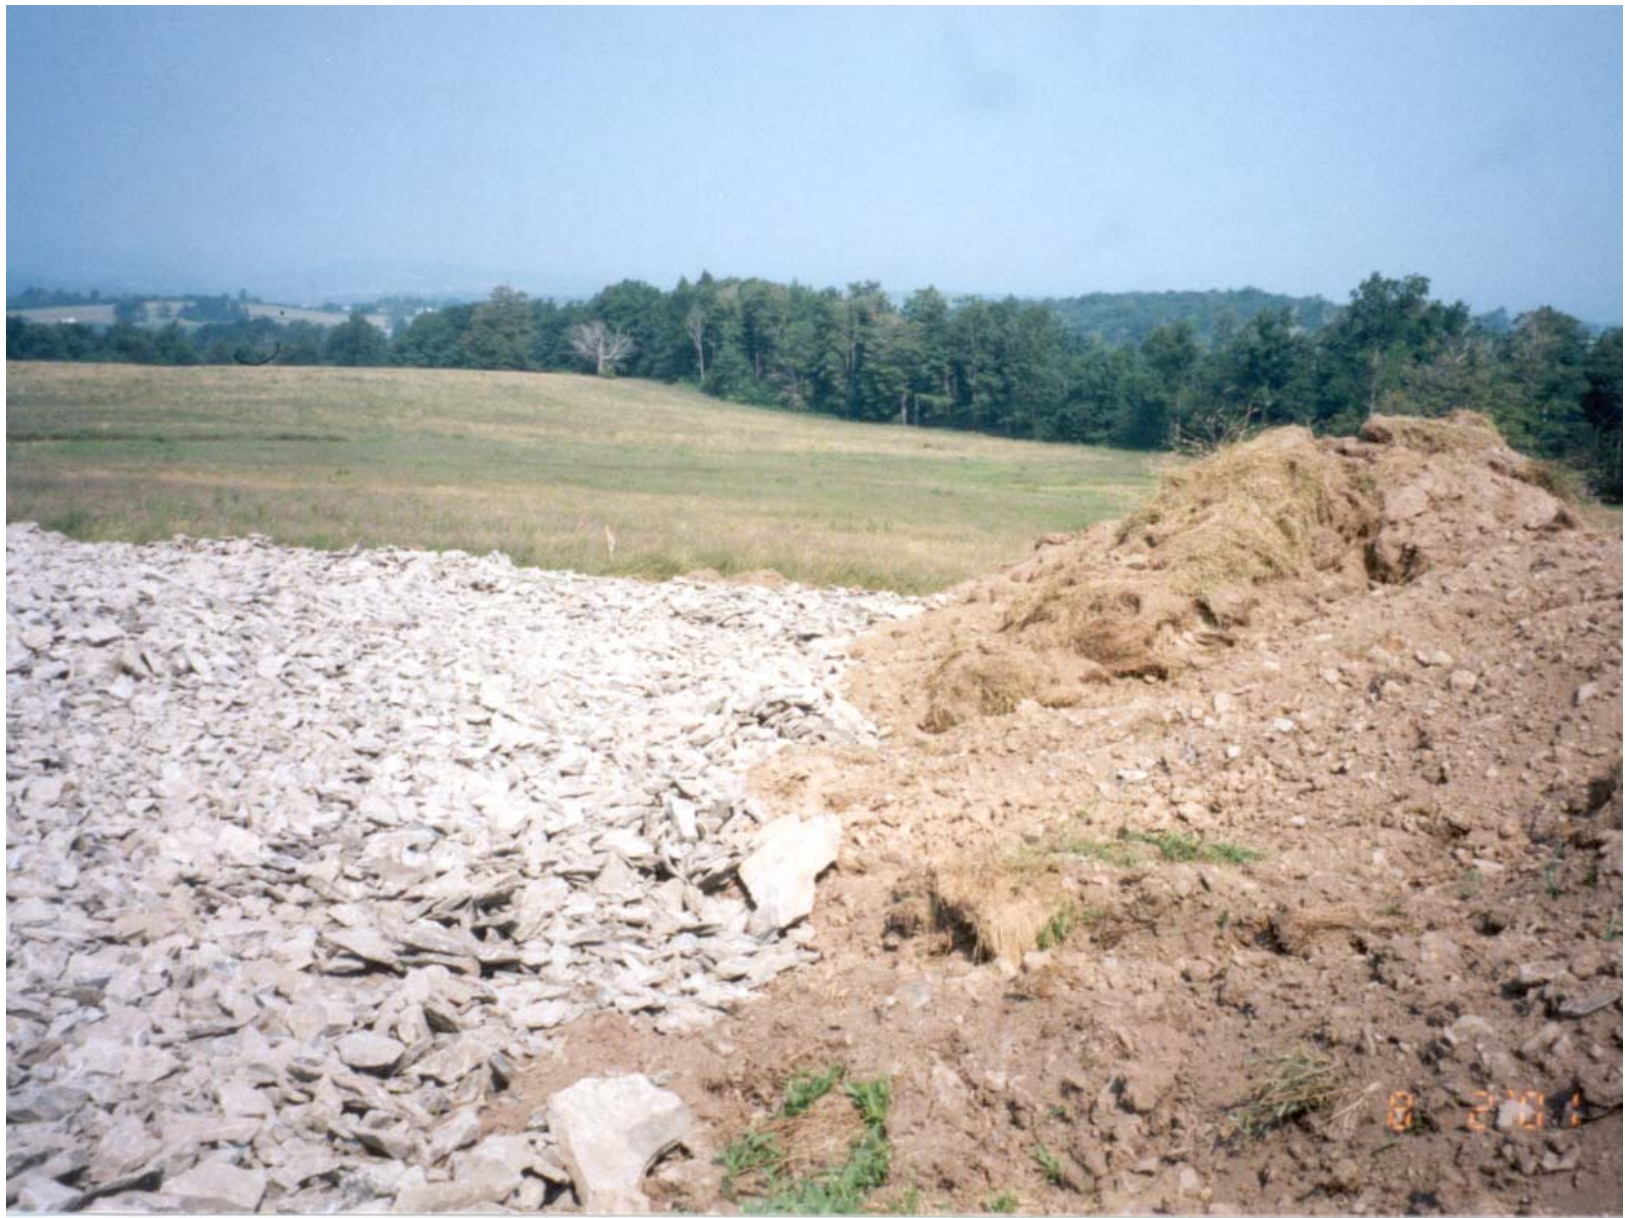
Some rock material mixed with topsoil material. This type of mixing should be avoided. Careful separation of the material is required during restoration.

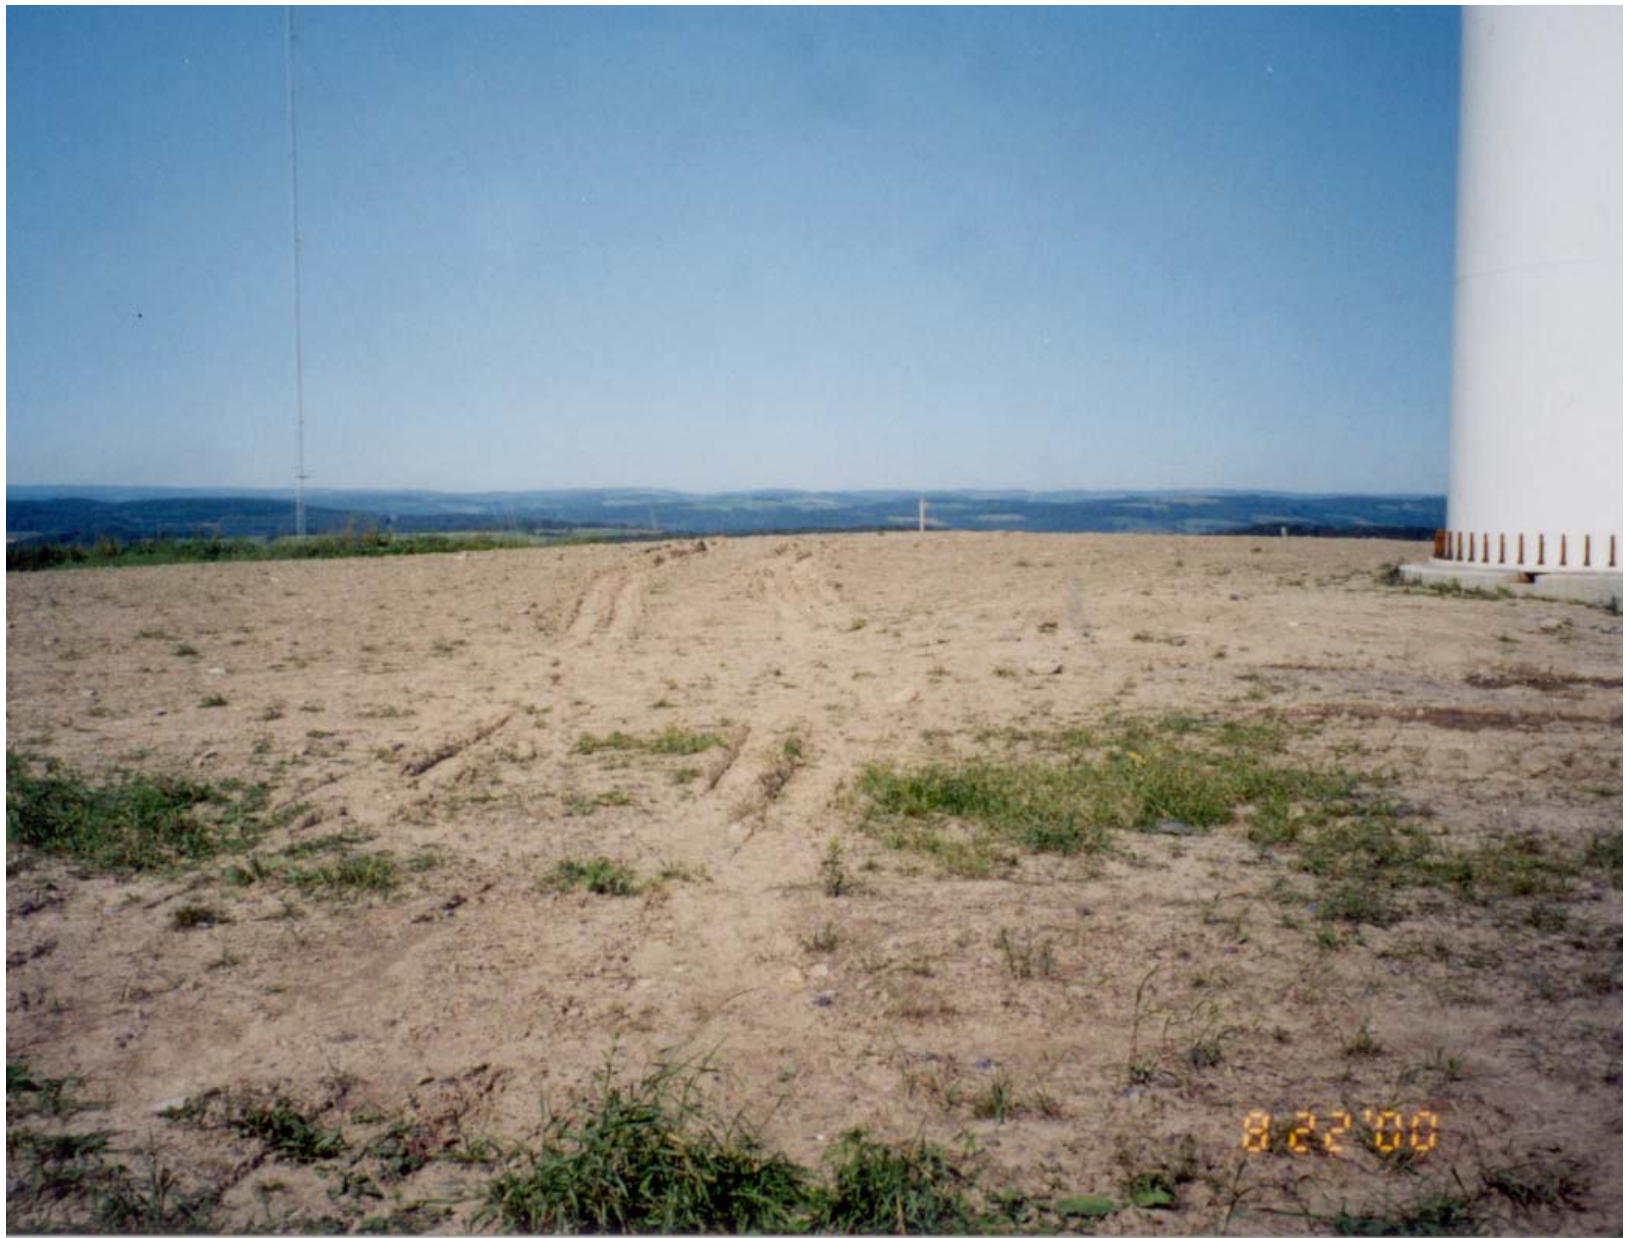
Seeding failed at the tower site because of lack of topsoil material on the surface. This photo was taken one year after the area was restored and seeded. Imported topsoil was required to establish a seeding.

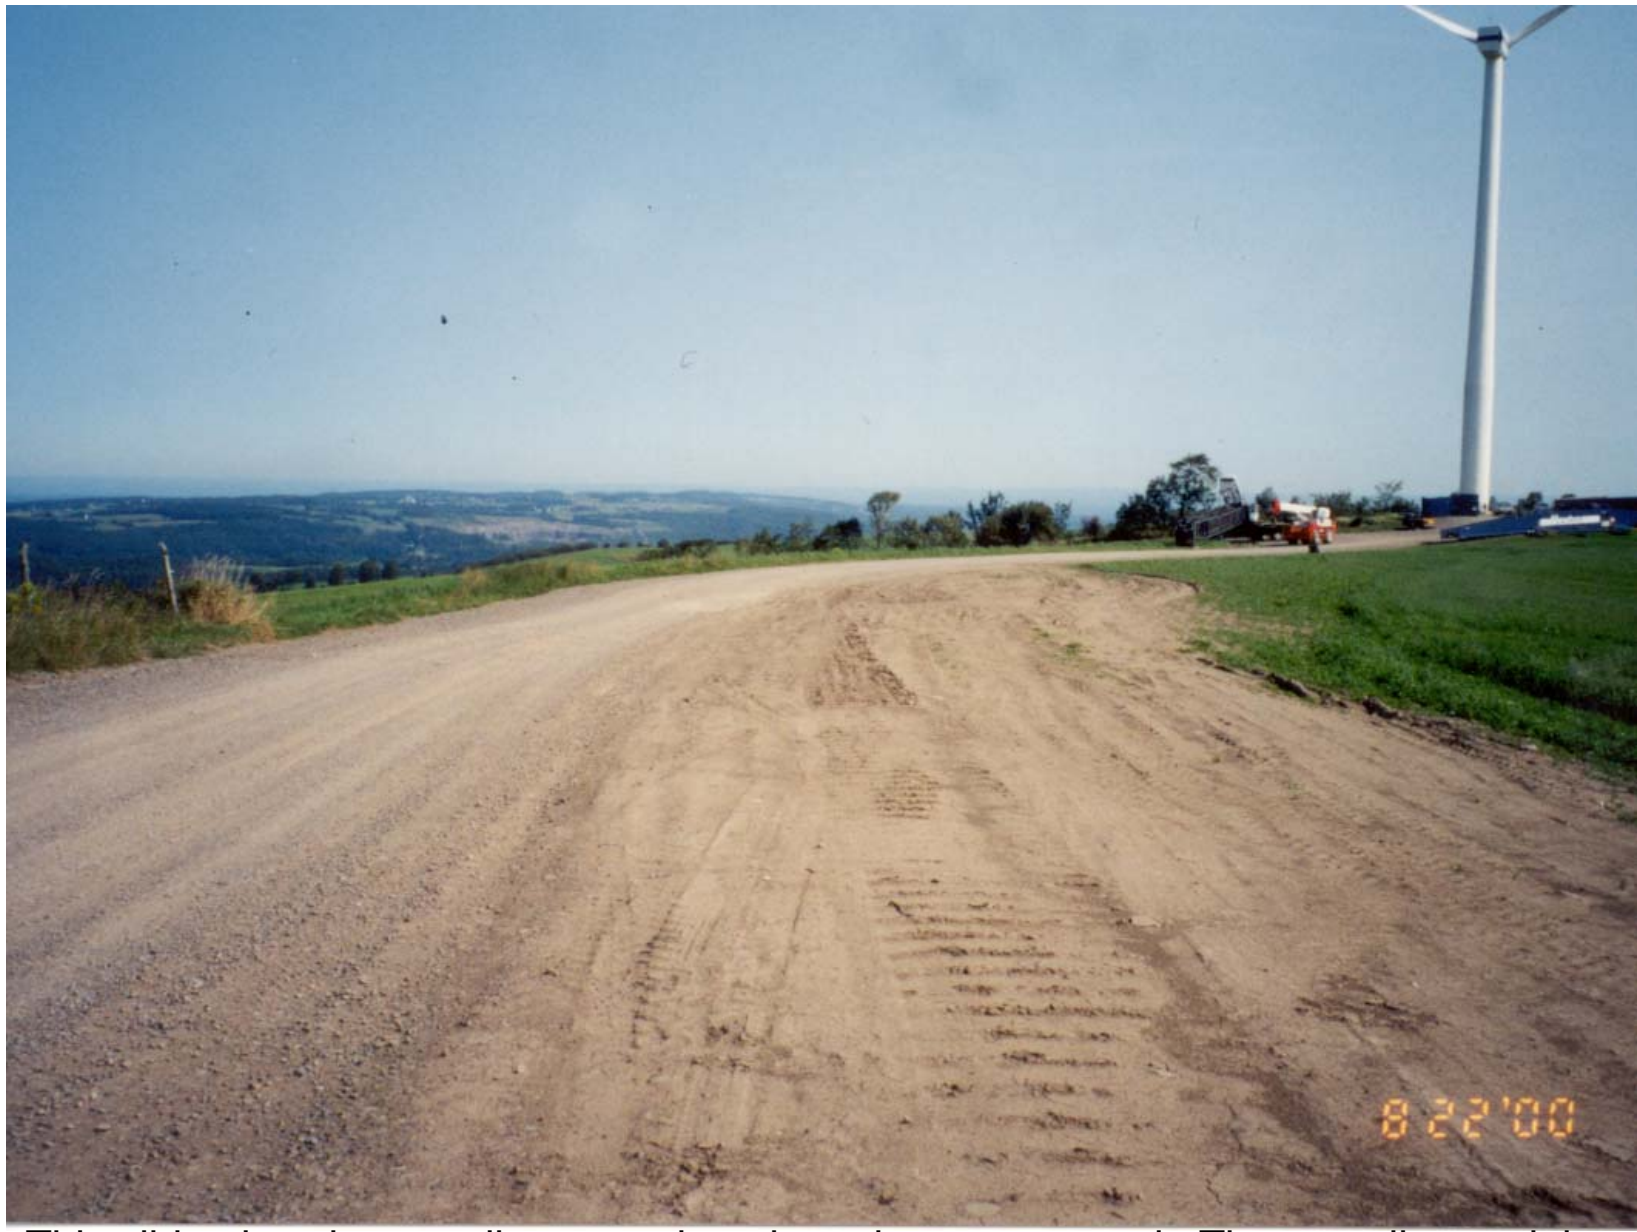
This slide also shows soil compaction along the access road. The topsoil material should be stripped from any agricultural areas used for traffic or vehicle parking. Subsoil decompaction is needed during restoration.

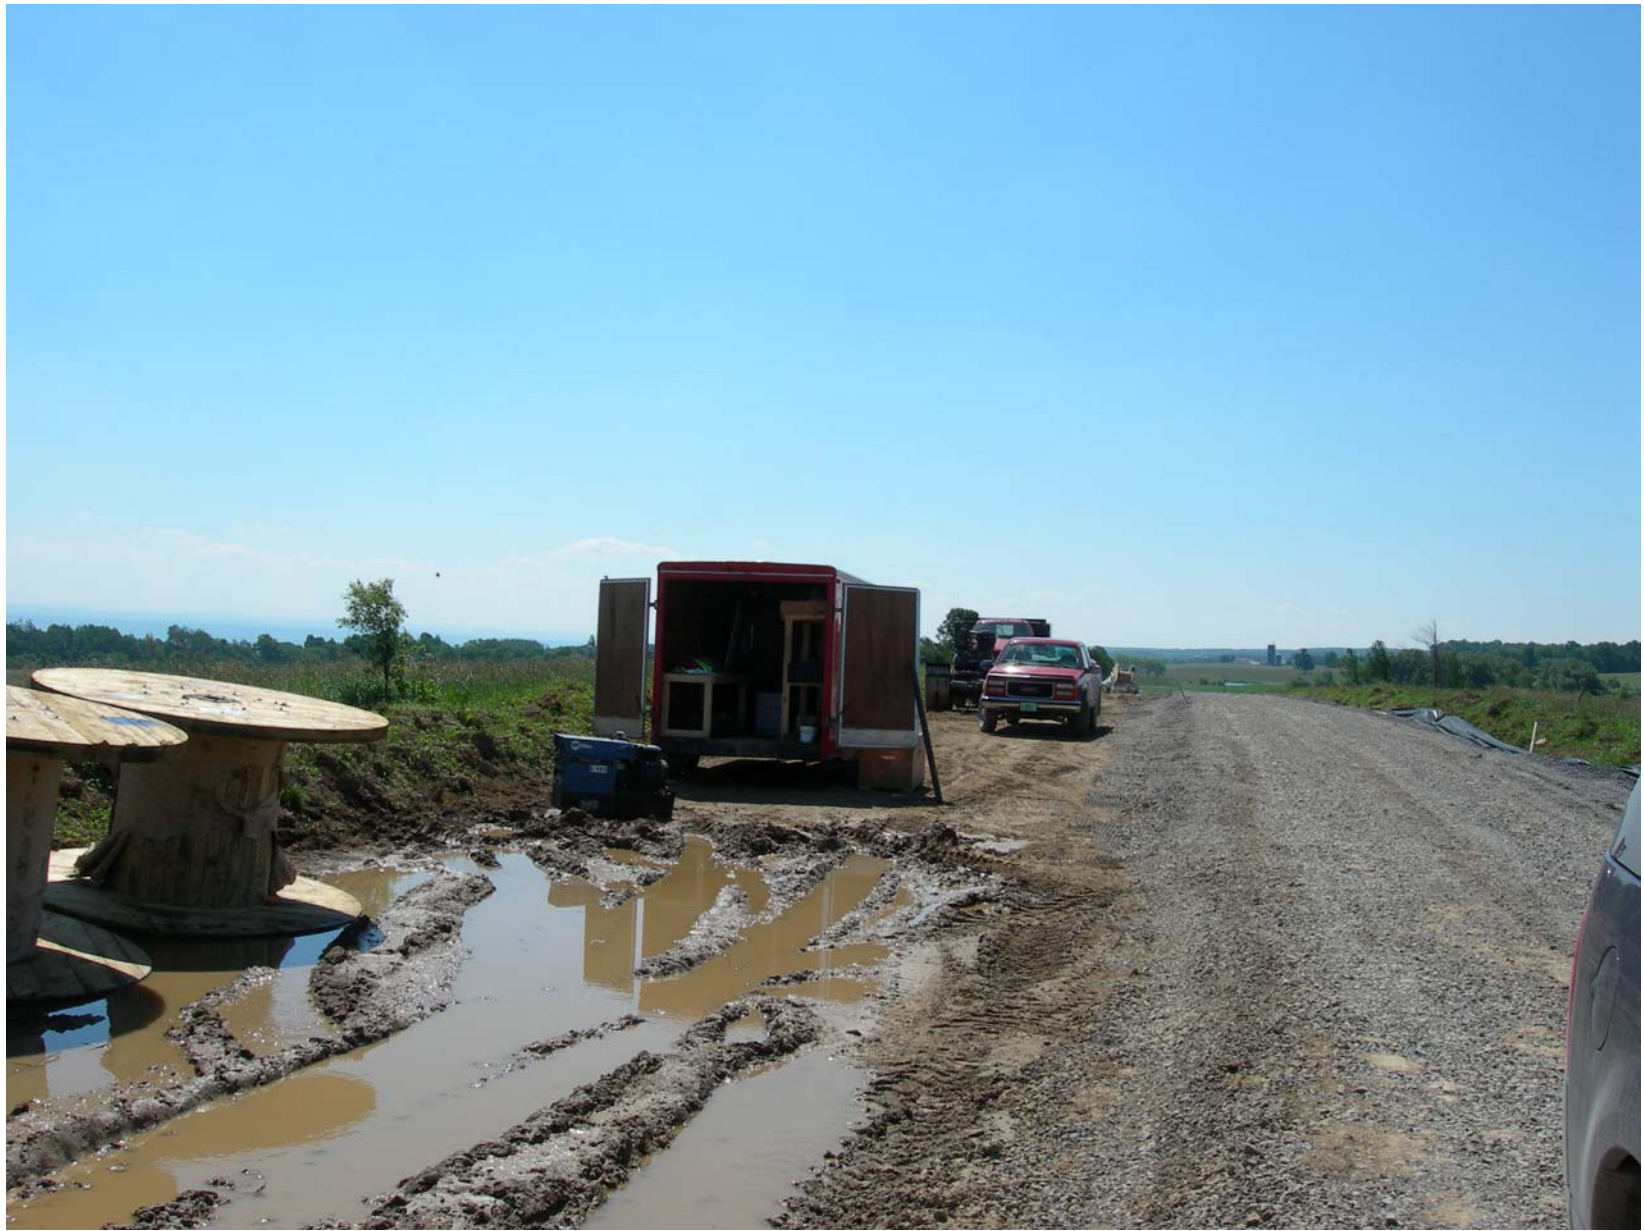
Topsoil stripped from area adjacent to access road to prevent damage as a result of vehicle traffic and parking.

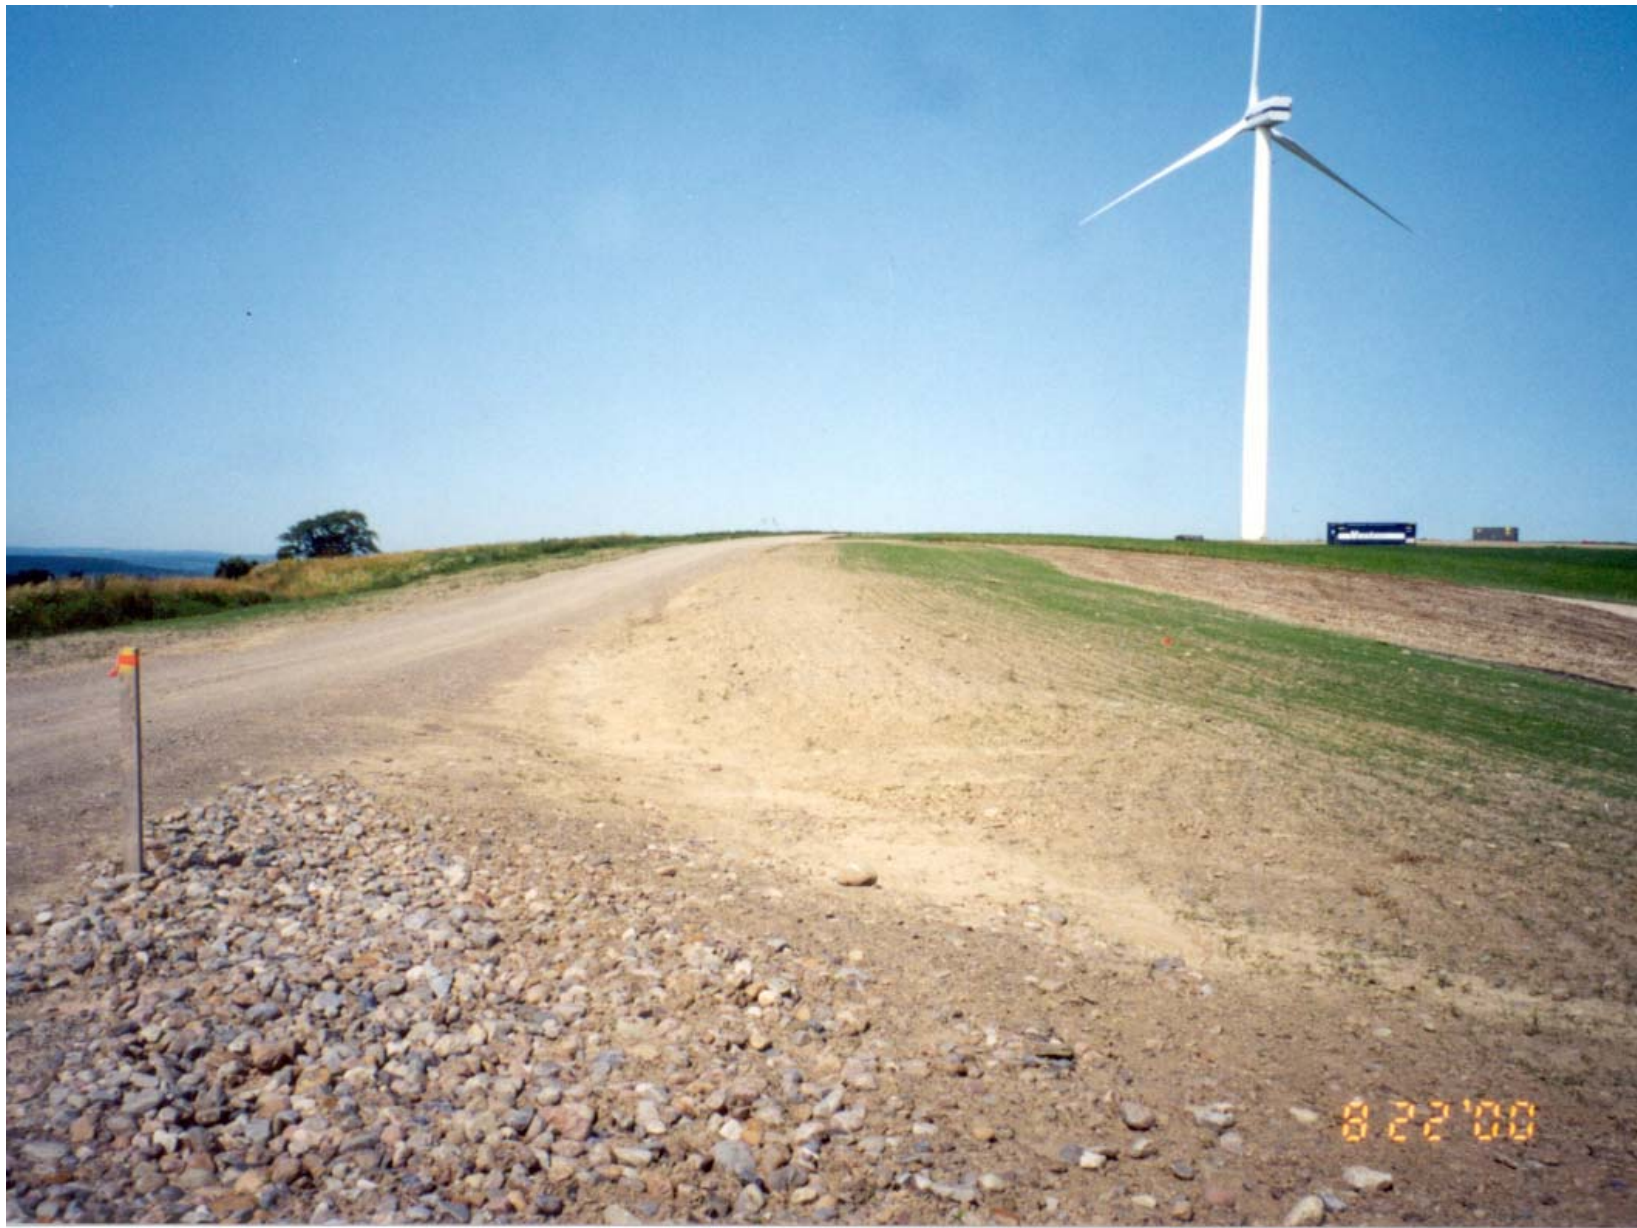
Seeding failed along the access road due to a lack of topsoil. Imported topsoil is needed to correct areas such as this.

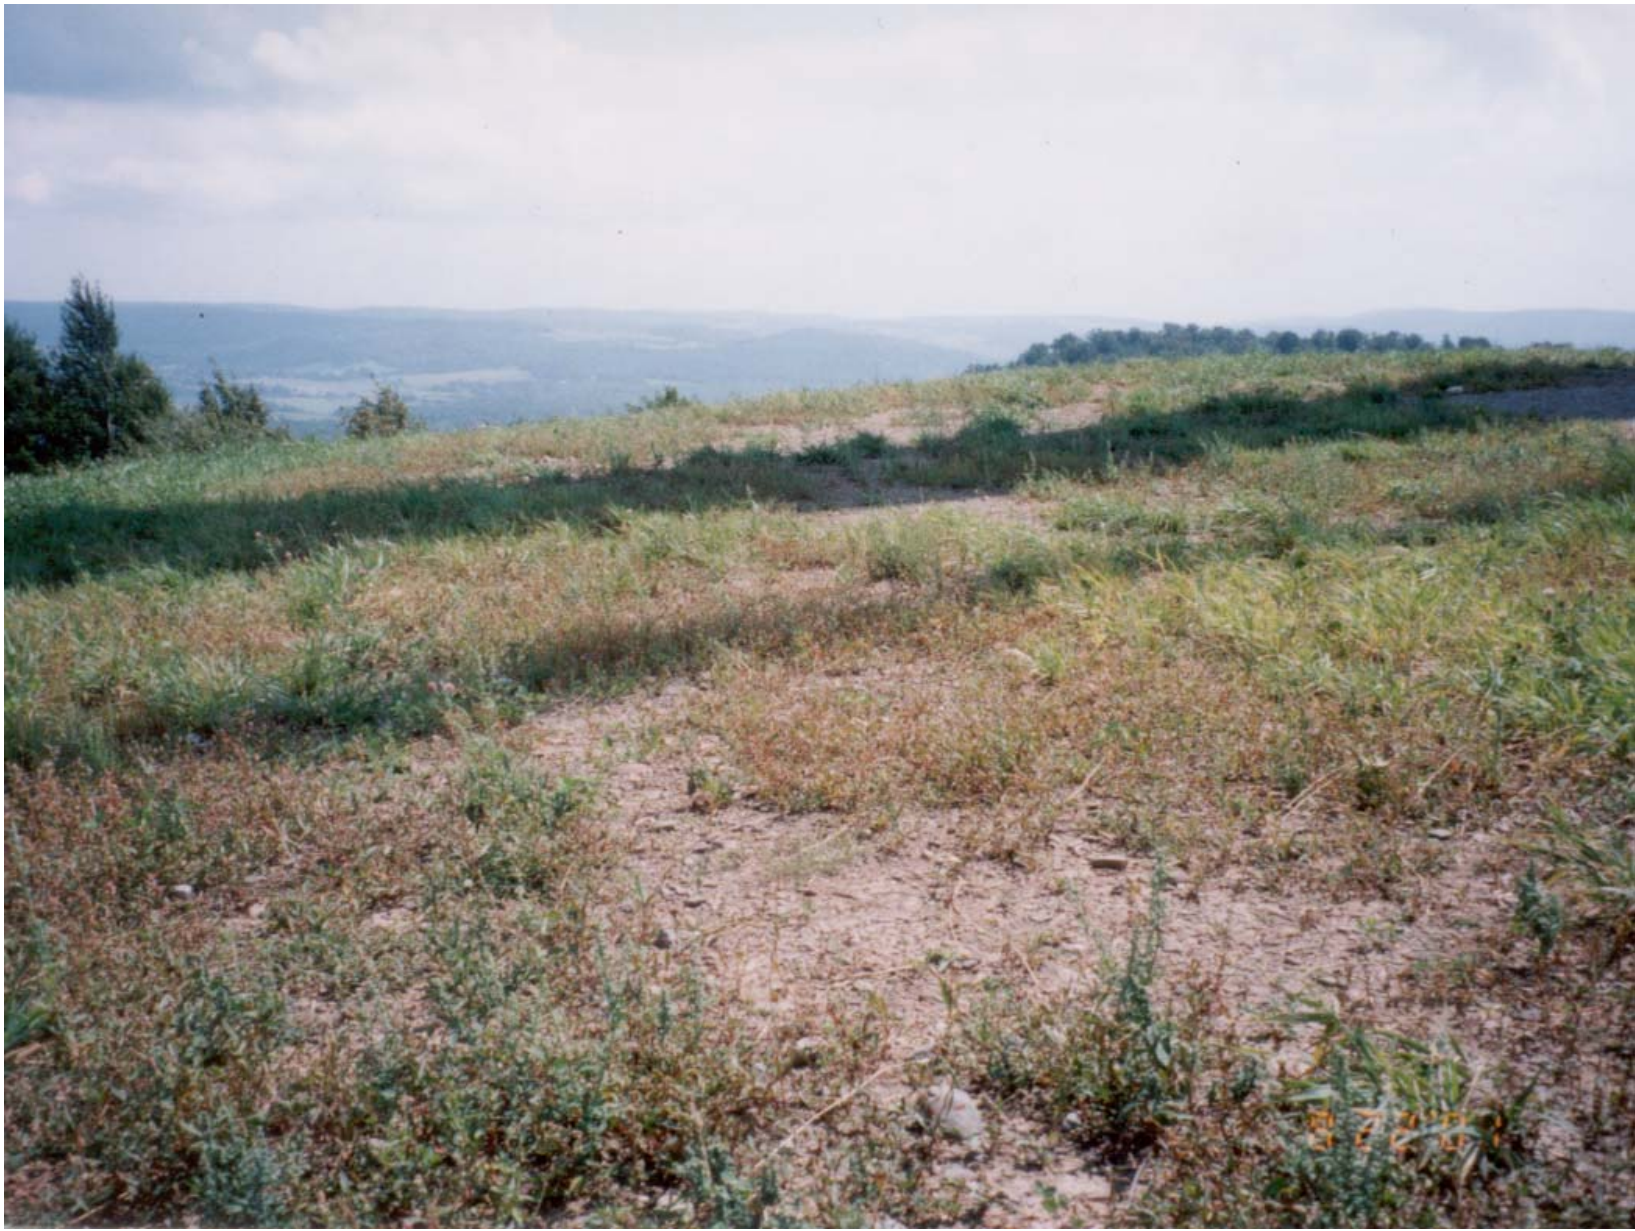
Poor vegetation two years after restoration because of the lack of topsoil. Only a few weeds can be seen growing. Imported topsoil is needed to restore the area.

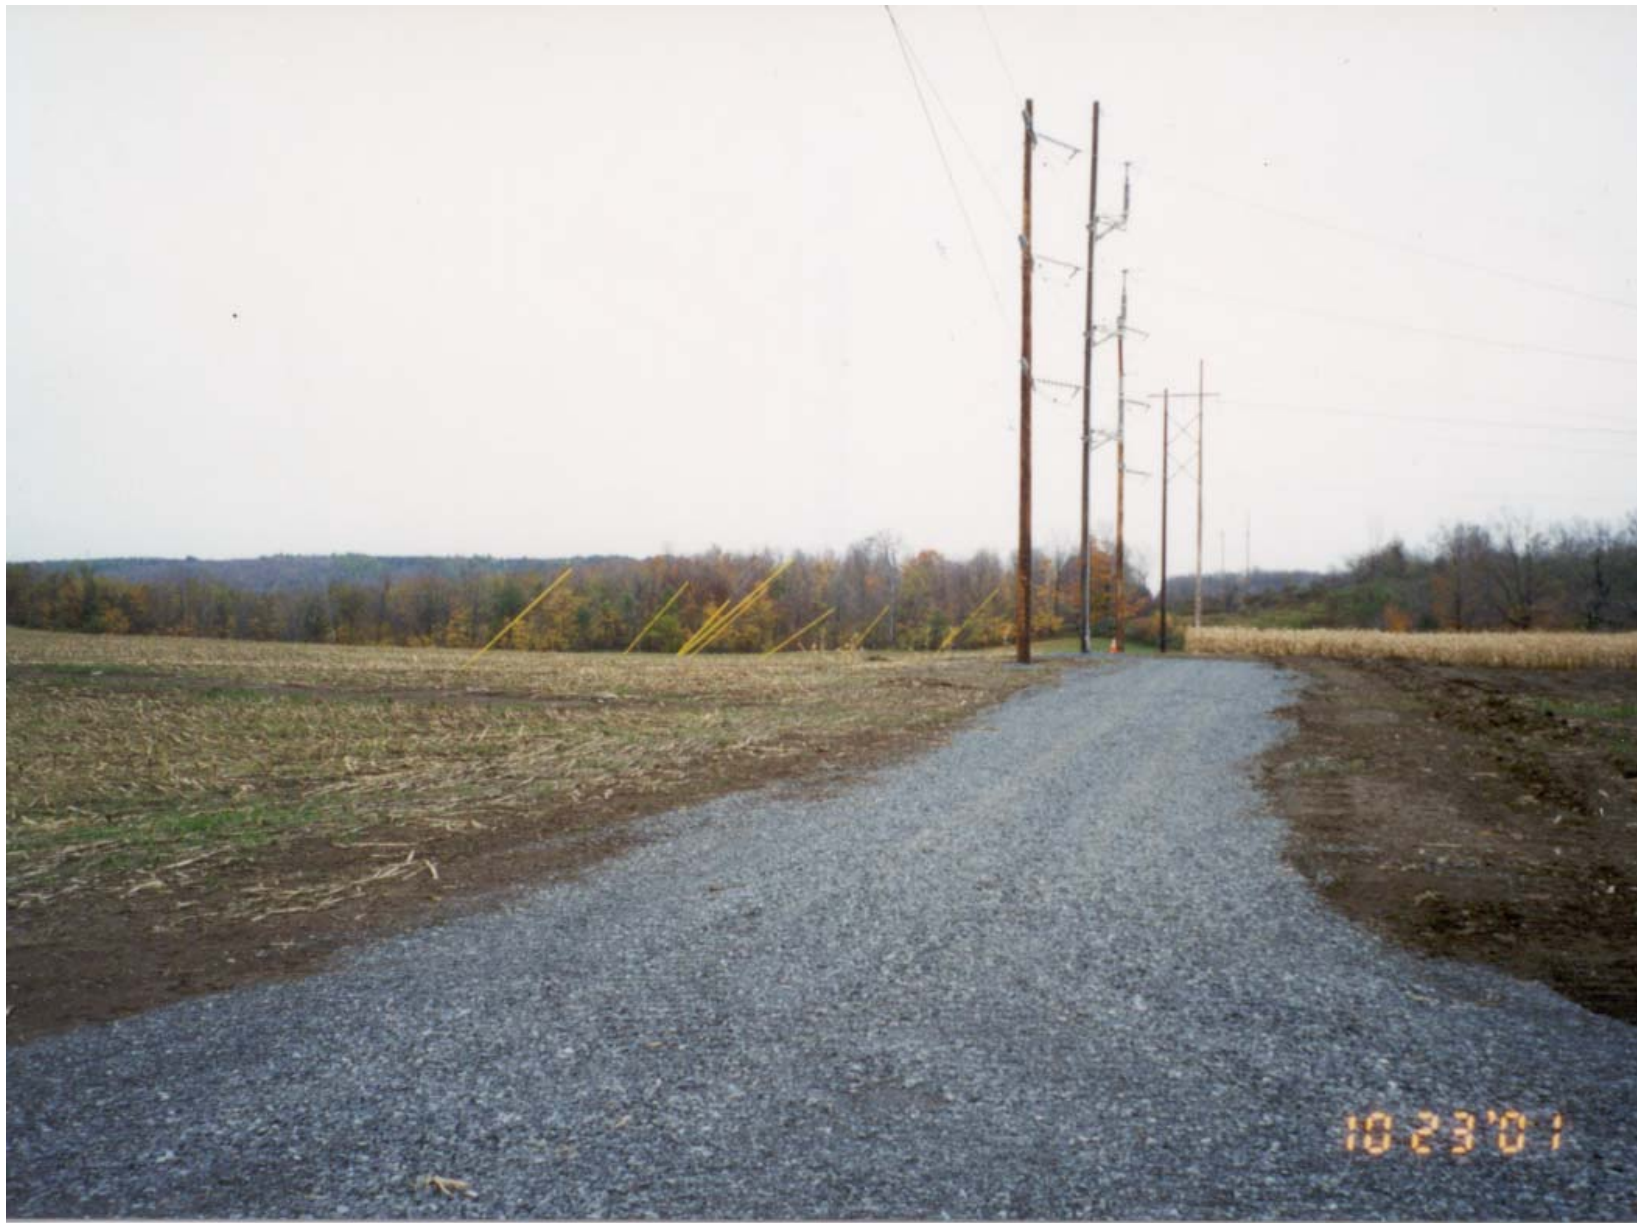
The connection between the substation and the transmission line can result in a significant impact to farm land. The addition of the guy wires and the access road results in a loss of productive farmland and a loss in efficiency during field operations.
